Flight Advisor Corner by Hobie Tomlinson

May 2012

Annual Safety Issue

Controlled Flight into Terrain (Pt. II)

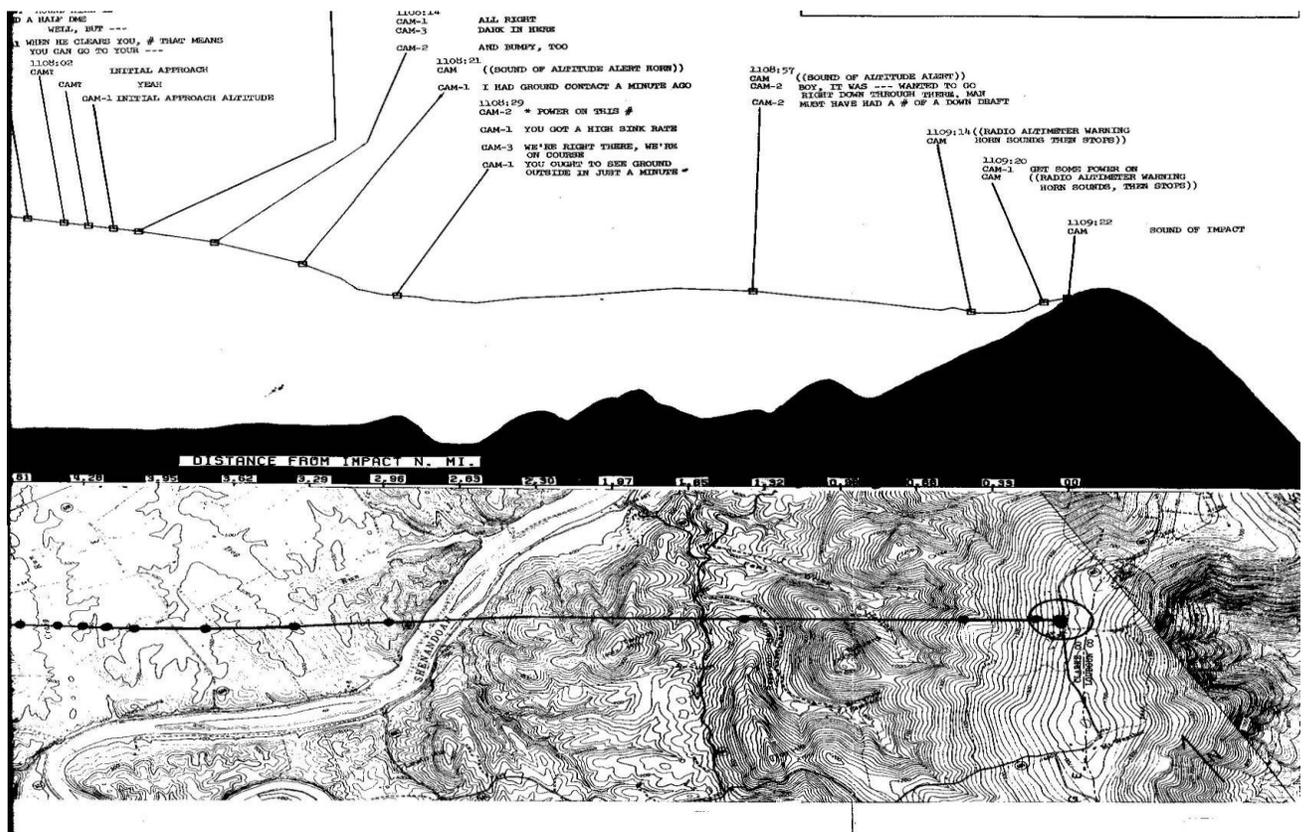
TWA Flt 514 Profile – Mt. Weather, VA – Accident that Started it All

B727-231 – N54328 – December 1st, 1974 – 92 fatalities
